Product Repair Bulletin

P/N 698198/379518

Interstage Housing Assembly

NHA: GTCP85 Series APU

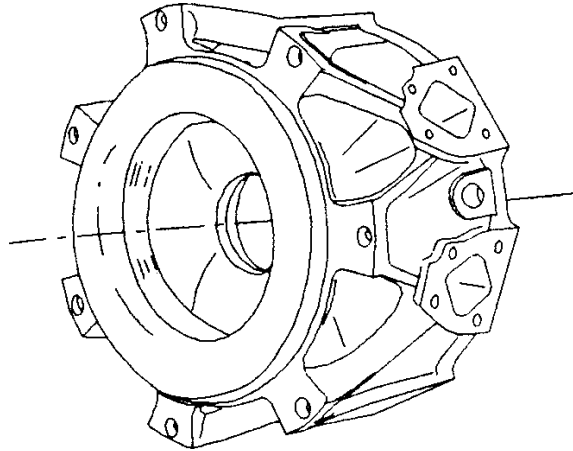
Repairs for OEM Manual 49-21-73:

Dress minor damage of surface F.
Metallize surface F.
Primer buildup surface F.
Metallize diameter A.
Metallize diameter B.
Metallize surface E.
Metallize diameter C/o-ring groove.
Machine surface F.
Machine diameter A.
Machine diameter B.
Machine surface E.
Machine diameter C/o-ring groove.
Fabricate/install -20 contour plug.
Clean/iridite.
Apply epoxy paint.
Set-up to install mount pad inserts as required.
Procure/install MS21209C1-15 insert. (28)
*Cone lip replacement is accomplished by
- = Fabricate/install -19 Plug = - per Britt Metal Major Repair 9107243.*
