## Product Repair Bulletin

P/N 3607748/379529/966580/976987/3850089

### Exhaust Pipe Assembly

NHA: GTCP85 Series APU

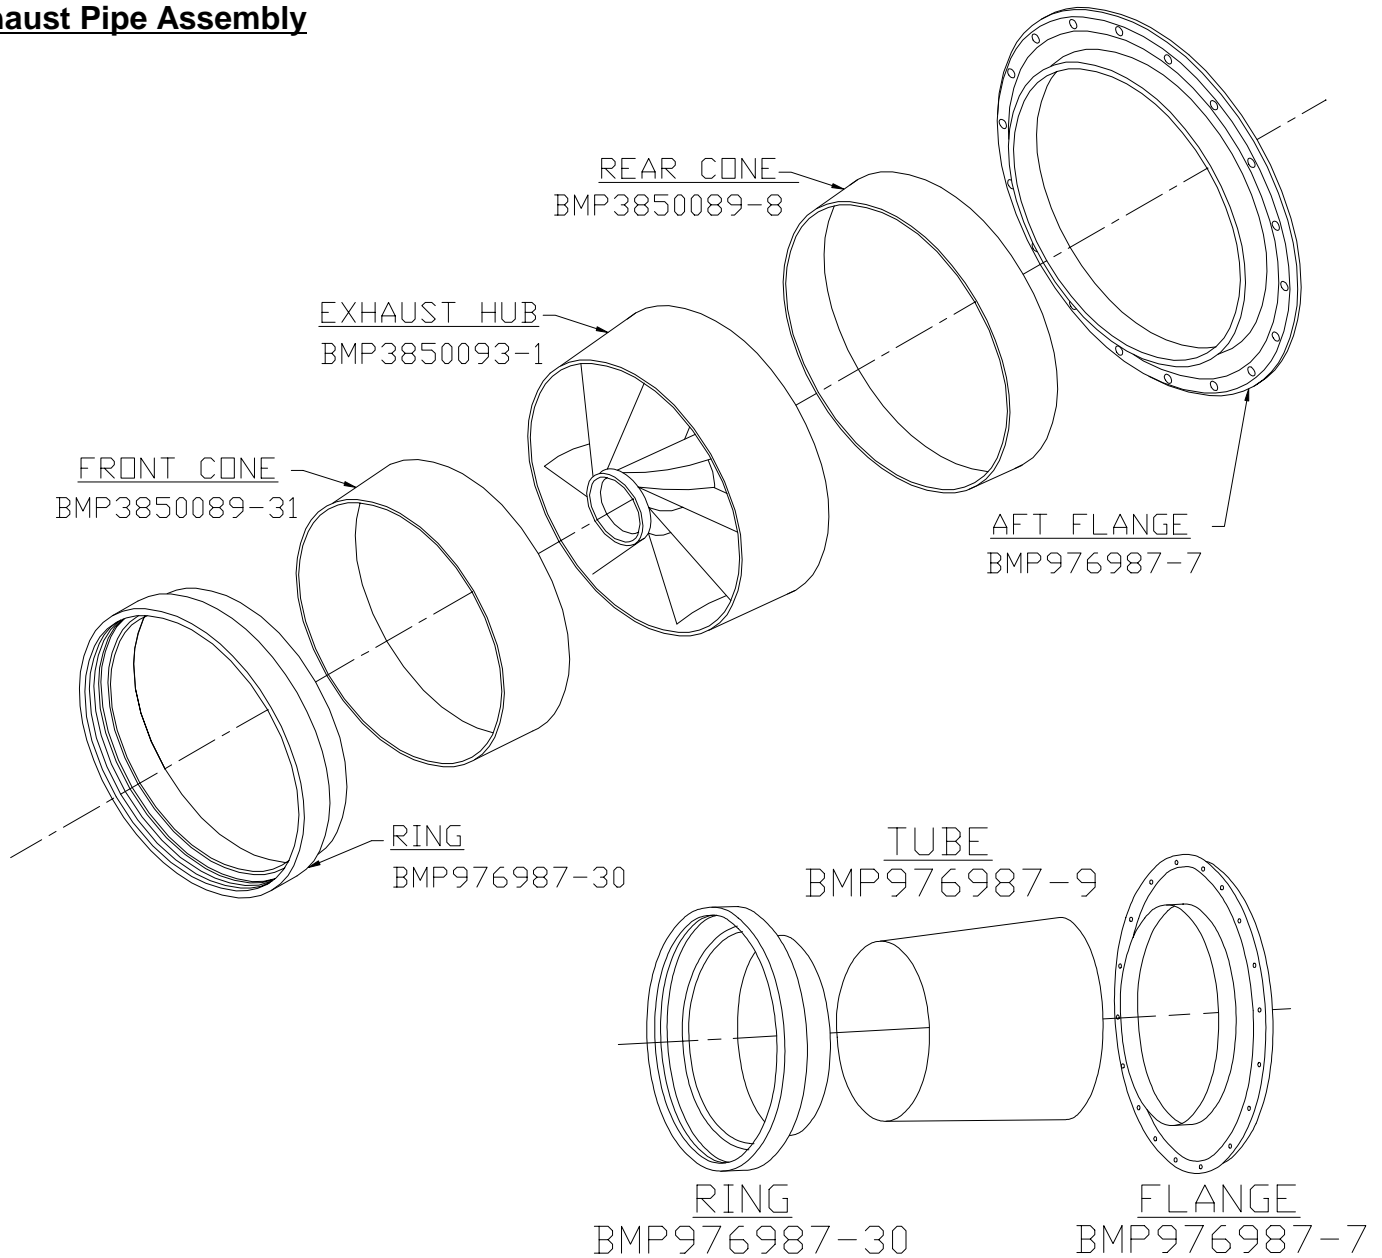
**P/N 3607748/379529/966580/976987/3850089**  
**Exhaust Pipe Assembly**

**NOTE: P/N 379529 and P/N 976987-1 are converted to P/N 3607748-1 by incorporating the -9 tube and -7 aft flange per Garrett S/B 49-A5078 and BMP Major Repair 9004111.**

- Fabricate/Install -30 Forward Flange.
- Fabricate/Install -9 Tube.
- Fabricate/Install -7 Aft Flange.
- Fabricate/install -9 Tube and -7 Aft Flange.  
*Converts 379529 & 976987 to 3607748 per S/B 49-A5078*
- Fabricate/Install BMP 3850093-1 Exhaust Hub.
- Fabricate/Install -31 Forward Cone.
- Fabricate/Install -8 Rear Cone.
