Product Repair Bulletin

P/N 695709/899323/695142

Combustor Cap Assembly

NHA: GTCP85 Series APU

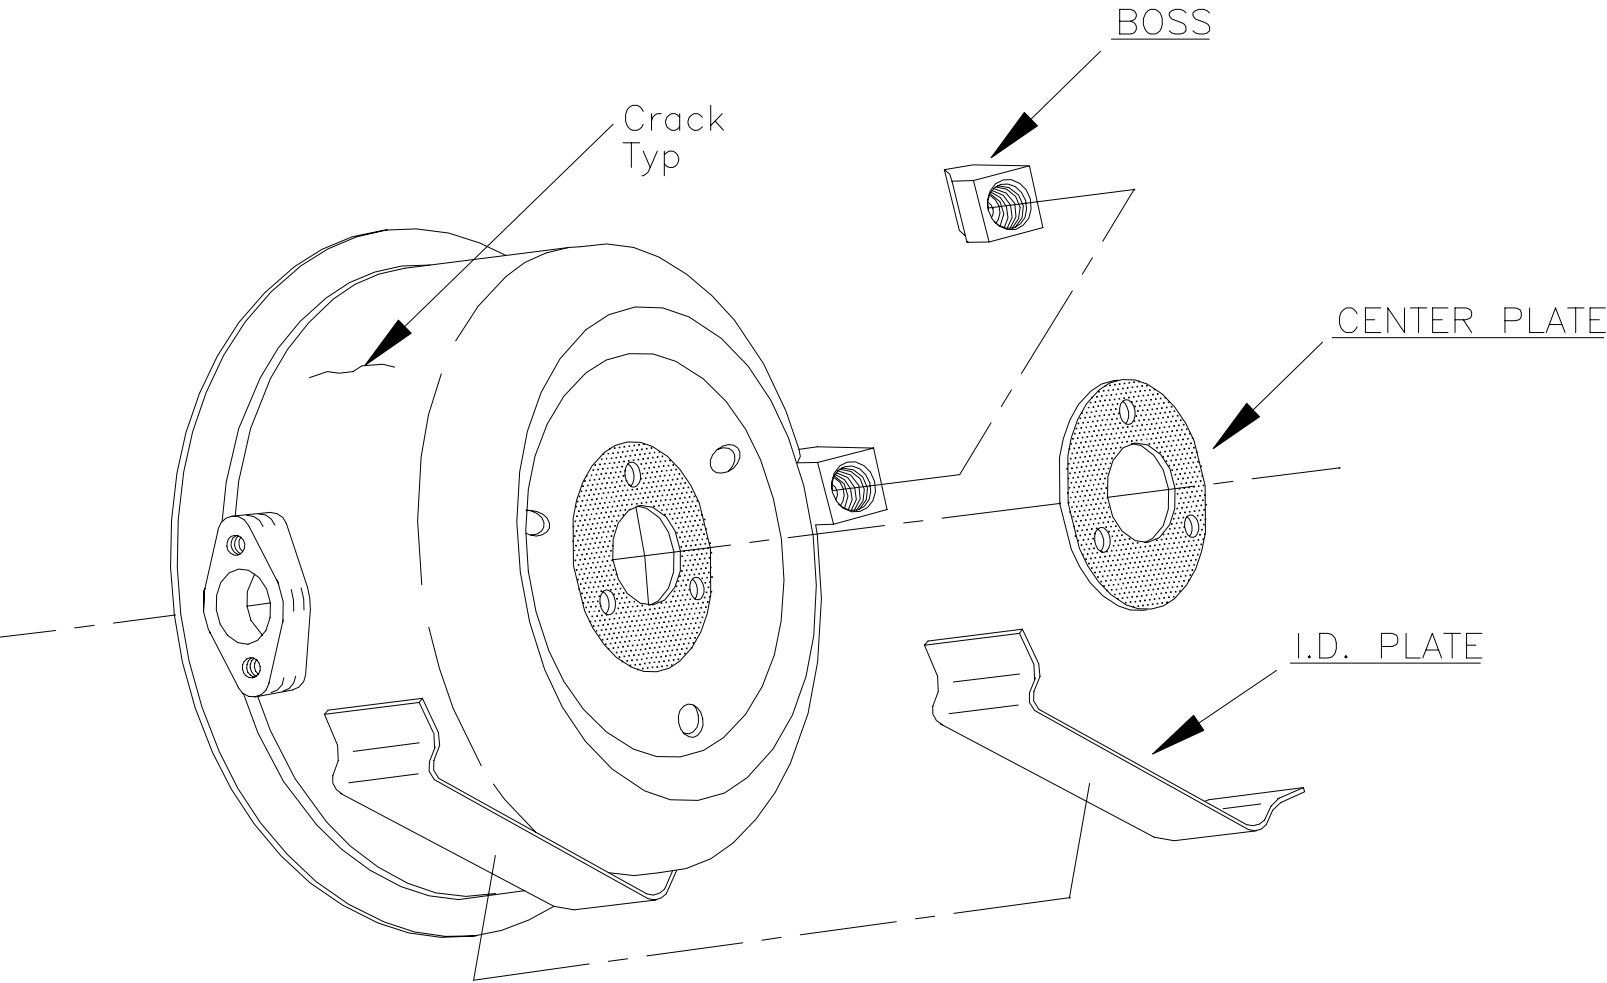
Combustor Cap Assembly

Cold straighten and size igniter location.

Weld/dress cracks.

Fabricate/install -20 center plate.

Fabricate/install -11 I.D. plate.

Fabricate/install -10 boss. (695142 only)
